# Severe rockburst occurrence during construction of a complex hydroelectric plant

G. Russo

Geodata Engineering (GDE), Corso Bolzano 14, Turin, Italy

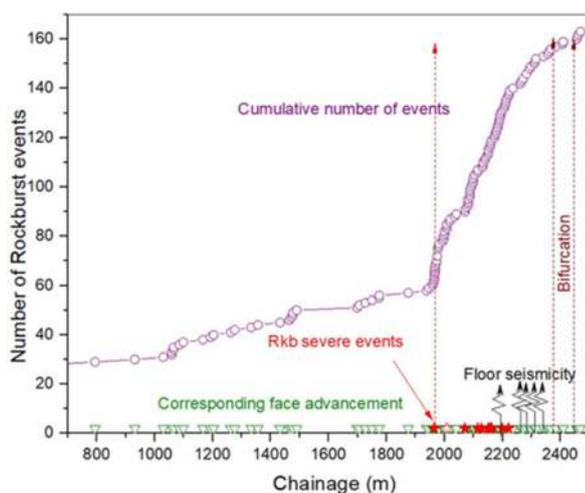
The intensity and frequency of seismic events dramatically increased while excavating one of the access tunnels to a powerhouse, just after a lithological contact between pyroclastic tuff and andesitic lava of the Abanico Western Formation (Oligocene-Miocene) with about 800 m of overburden (Figure 1).

Figure 1. Cumulative number of rockburst events in access tunnel. Red dotted line coincides with lithological contact, while arrow indicate the first severe rockburst.

- Fracturing of the shotcrete along preferred alignment, without fall-down or ejection of fragments because of the chain-link mesh protection;
- local shear cut of the threadbars. This kind of failure prevalently occurred at distance <0.5m from the bolt heads (no twin-strand cables shear failures).
- cracks in the invert zone, sometimes consequence to very impressive up-down movement of the floor, like earthquake shaking associated to seismic waves propagation (see also Figure 1).

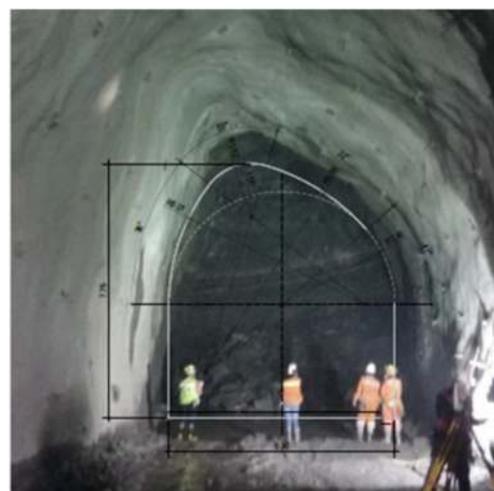
Figure 2: Initial modification of the excavation shape by Contractor to follow the failure mode (7.35 m of vertical dimension)

After the first severe event reported in the Figure 1, a progressively increasing tendency to overbreaks and rock block ejection was observed in the tunnel (Figure 2).

Measures for controlling the dangerous brittle instabilities included modifications to the excavation shape (Figure 2) and adding a joint in the shotcrete in tunnel crown with the purpose of reducing stress concentrations (see Figure 3). The support system was based on two (1.5m x 1.5m) sequences of rock reinforcement (L=3m) by PM16/24 Swellex and Shell Anchored bolts (d=25mm) alternated with D-Bolts (22mm), in combination with (70+50mm) Fiber Reinforced Shotcrete (FRS) and two 6mm weld-meshes (ACMA C188).

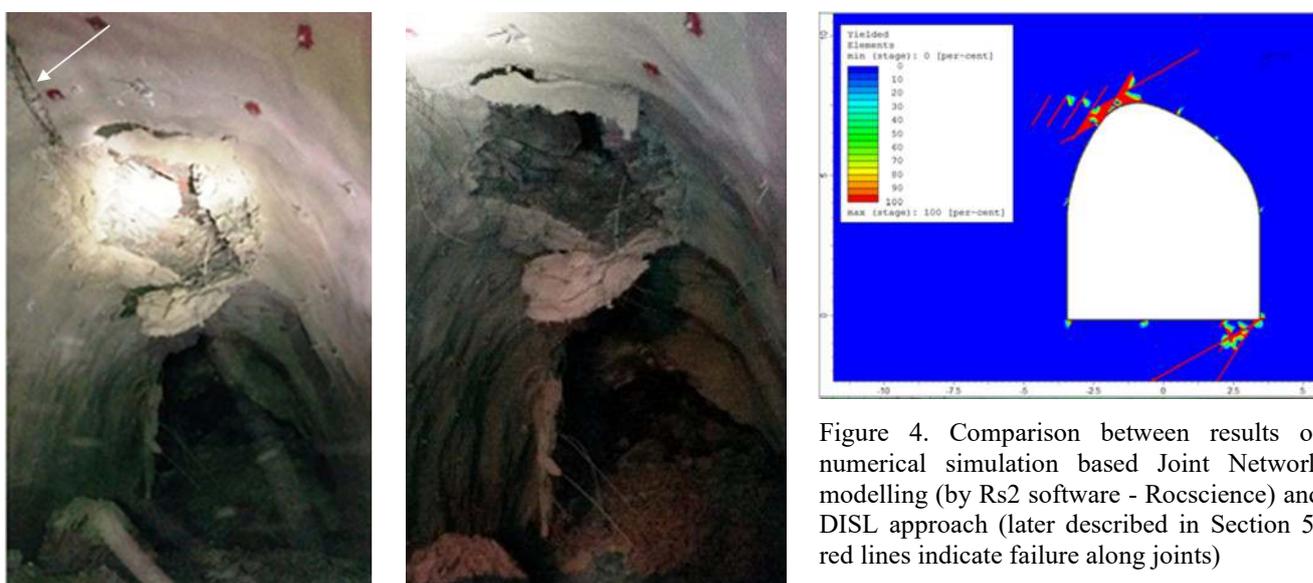
These technical solutions were however not able to control the damage from a very violent rockburst event that occurred at about Chainage (pk) 2+070 (overburden  $\approx$  930m), resulting in severe support failures at about 10m from the tunnel face followed by further support damage up to about 30m from the face (Figure 3).

Figure 3. Support damage by severe rockburst at pk 2+070 (the arrow indicates the joint in the shotcrete).

Depending on the possible interaction between the different elements of the support system and relative failure occurrences, it was estimated that the described rockburst event at pk 2+070 (Figures 3-4) released energy at least for 20 kJ/m<sup>2</sup> and up to about 30 kJ/m<sup>2</sup>. Therefore, the latter was considered the reference energy demand for rockburst design.

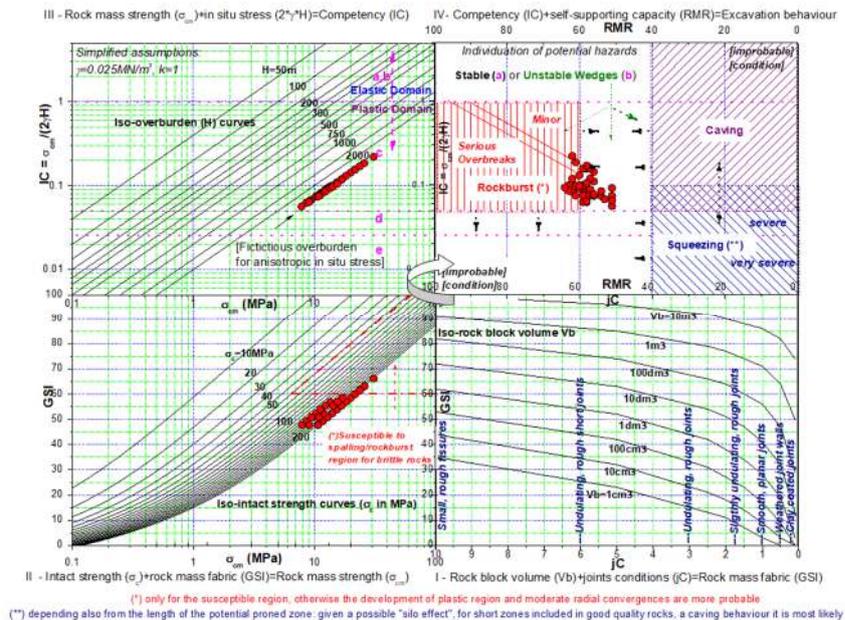
In the so-called "GDE multiple graphs" of Figure 5 (Russo, 2014), the main geomechanical properties (GSI, UCS,  $IC = \sigma_{cm}/\sigma_{tang(max)}$  and RMR) from about Chainage pk 1900m onwards in the access tunnel are shown in combination with the expected excavation hazards (quadrant IV) for the relative plane-strain principal stresses.

As it can be observed from this figure by proceeding clockwise from the bottom-right to the top-right to the top-left quadrant (I→IV; see basic equations rationale reported outside the graph):

- I quadrant (bottom-right): in the case not implemented for GSI assessment
- II quadrant (bottom-left):  $GSI \approx 47 \div 66$ ;  $UCS \approx 150 \div 200 \text{ MPa}$
- III quadrant (top-left):  $IC \approx 0.05 \div 0.2$
- IV quadrant (top-right):  $RMR \approx 50 \div 65$ . Consequently, in terms of excavation behaviour, serious overbreaks conditions, eventually associated to severe rockburst, are expected in alternative to rock wedges instability.

Figure 5. Application of the GDE Multiple graphs (Russo, 2014) for the 1+900÷2+070 Adit stretch. Note that "fictitious" overburden in top-left quadrant allows for considering the effective max tangential stress ( $3\sigma_1 - \sigma_3$ ) related to  $k \neq 1$ .

In Figure 8, the Dynamic Rupture Potential (DRP, Diederichs, 2017) is estimated for the same UCS range reported in Figure 5, by consequently remarking an indication of possible rock ejection in case of unsupported or ineffectively supported excavations. As suggested by Stacey (2016), ejection velocity could even be much higher than indicated in the graph and velocity in the order of 10m/s are not uncommon, thus adding uncertainty to design.

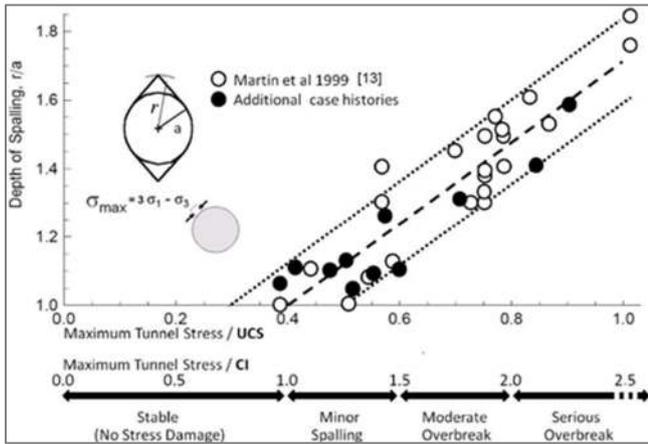
The assessment of rockburst hazard through the the GDE multiple graph refers to the spalling classification proposed by Diederichs et al., (2010; Figure 6), based on the empirical prediction of the depth of brittle failure as a function of the stress level  $SL = \sigma_{max}/UCS$  (Wiseman, 1979, reported in CRSH, 1996; Martin et al., 1999). In Figure 7, the Stress Level (SL) is detailed for an Adit stretch with reference to the increasing overburden and the localization of rockburst events.

Figure 6. Empirical prediction of Depth of Spalling/Failure=DoF) for  $SL < 1$ . The figure (Diederichs et al., 2010) is based on CRSH (1996) and Martin et al., (1999).  $CI = \text{Crack Initiation Threshold} = 0.4 \cdot UCS$  in the graph. According to Nicksiar and Martin (2013),  $CI = 0.35 \div 0.55$  for most of rocks. The cases in figure remark the maximum registered DoF, generally for brittle failures (no rockburst).

It can be observed that VSR and  $\Delta SED=0$  overlaps in the tunnel crown, so consistently estimating the potential thickness of unstable rock mass. Numerical model does not give the maximum (extreme) DoF as per Figure 6.

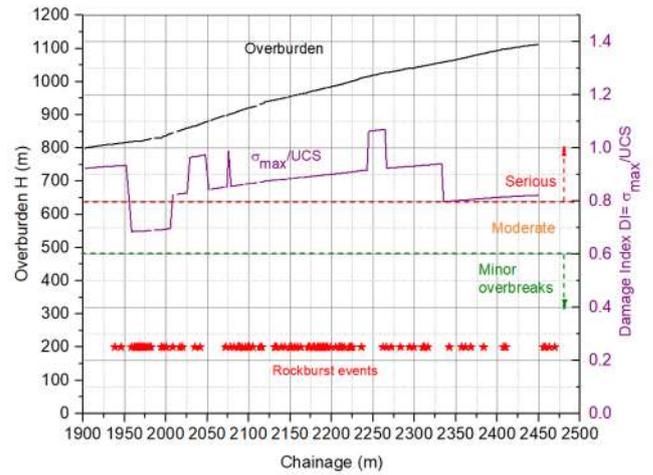
Figure 7: Relation between rockburst events and the calculated Stress Level. Note that the SL drops after Chainage pk 2+320 was hypothesized due to increases in UCS derived from laboratory tests.

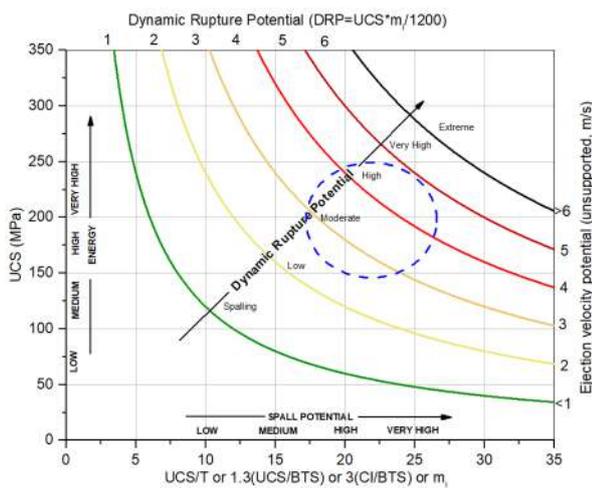
Figure 8: Dynamic Rupture Potential (DRP) for massive rock (Diederichs, 2017) with approximate indication of typical Andesitic Lavas properties

According to Cai and Kaiser (2018), the brittleness indices in Figure 8 in the horizontal axis are indicators of StrainBurst Potential (SBP) and on the vertical axis of StrainBurst Severity (SBS). The UCS contributes to the severity of events, but other factors, particularly the “Relative Brittleness”, related to the excavation system stiffness (Tarasov and Potvin, 2013) need to be considered.

Based on the resulting VSR and the associated Depth of Failure (DoF), an estimate of the kinetic energy ( $E_k$ ) can be assessed. For the example in Figure 12, considering DoF~1m and the potential ejection velocity derived from Figure 8, the previously remarked energy demand for design is approximately confirmed.

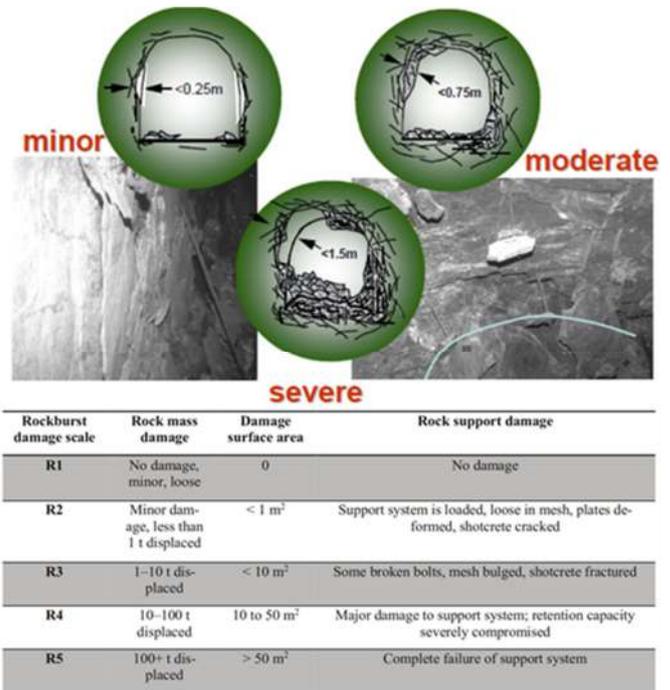
Figure 9: Above: Classification of rockburst damage severity for unsupported excavations (Kaiser et al., 1996). Below: Rockburst damage scale for support (Potvin, 2009; modified by Cai and Kaiser, 2018)

For unsupported tunnel (width and height dimension in the range of 3÷6m) Kaiser et al. (1996) defined the rockburst damage severity in terms of depth of failure as shown in the upper part of Figure 9. At the bottom of the same figure, the rockburst damage scale for support (Potvin, 2009, modified by Cai and Kaiser, 2018) is reproduced.

With reference to the table in Figure 9, the R3 grade of the scale can be assessed, but observing that the associated damage surface area is much more than indicated in the classification system.

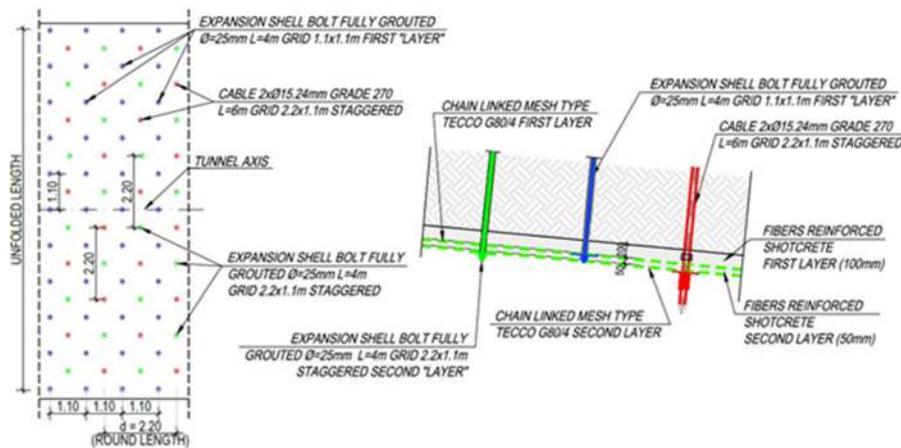
Considering the uncertainty on the effective interaction between holding/reinforcement and retention system, the weakest link issue and the potential ejection velocity, a double-layer solution was consequently dimensioned, as shown in Figure 10.

Figure 10: Double-layer solution dimensioned for severe rockburst occurrence

The double-layer solution (crown/sidewalls) typically involves two retention system components: Fibre-Reinforced Shotcrete (FRS) and high capacity chain-linked steel mesh (Tecco G80/4). Each component was combined with a radial reinforcement by fully grouted 25mm expansion shell threadbars or twin-(15.2mm) strand cables. The latter served as partial alternative holding elements for the second retention component, depending on excavation cross section.

Based on available results from tests on bolts and retention systems (in particular by the WASM Dynamic Test Facility, as reported by Villaescusa et al., (2015), CANMET, (2012) and *drop test* data reported by Potvin et al., (2010), including Kaiser et al. (1996) and Ortlepp and Stacey, (1997)), the reinforcement/holding system is called to adsorb in about 100-(150) mm of displacement the energy demand of reference with a Factor of Safety  $FS \approx 2$ , as recommended by CRSH. At the same time, the retention component guarantees a capacity itself in the order of demand, offering by the chain-link mesh component some further deformational margin.

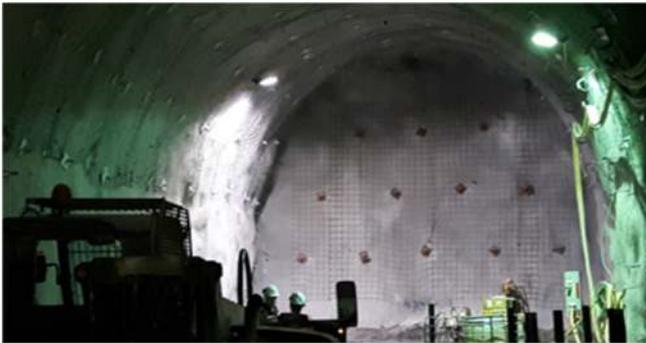
A representative image of the application of the Double-layer solution is presented in Figure 11.

Figure 11: Examples of application of the Double-layer solution and tunnel face control

Furthermore, as a measure for some controlled dissipation of seismic energy, a curved excavation shape was used for the invert and by temporarily leaving at the face the blasted rock, in order that invert zone results filled up to the horizontal working plane. The standard technical solution also included the retention and reinforcement of the tunnel face by FRS+welded mesh and PM24 Swellex bolts. Forepoling was applied in particular critical stretches to further control overbreak.

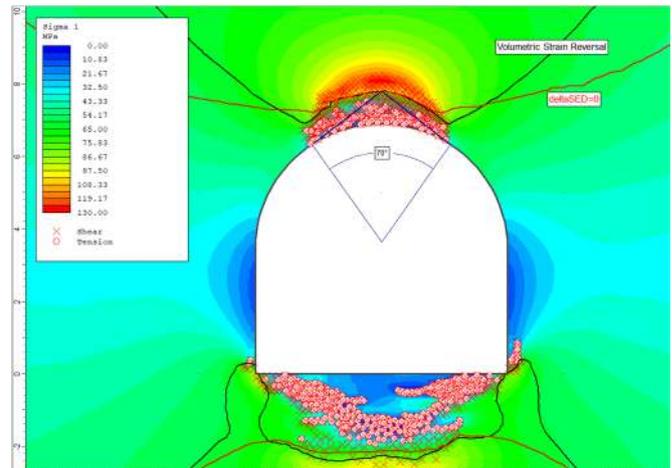
Figure 12. Example of results of numerical modelling by Rs2 in terms of major stress (Sigma1) and yielding zones. VSR and the iso-line  $\Delta SED=0$ , as well as the potential brittle failure notch according to Martin et al. (1999) are additionally remarked.

In Figure 12, the results of an example of implementation of DISL by continuum are provided in terms of major stress (Sigma1) and yielding zone (x for shear and o for tension). Moreover, the following additional elements are highlighted:

- The Volumetric Strain Reversal (VSR): according to Perras and Diederichs (2016), VSR indicates the transition between isolated and connected damage within the rock mass surrounding the excavation and should be comparable to the depth of brittle failure investigated by Martin et al., (1999, Figure 6). Consistent with this reference, the approximate dimension of the potential brittle failure notch is as well reproduced.

- An approximate indication of the limit between zones in which Strain Energy Density (SED) reduced (close excavation) or increased in the passage from elastic peak to post-failure condition. Therefore, this limit is remarked by the union of points in which SED did not change, i.e. the iso-line  $\Delta SED = SED_{\text{post-failure}} - SED_{\text{peak}} = 0$ . The Strain Energy Density is calculated by the following formula:

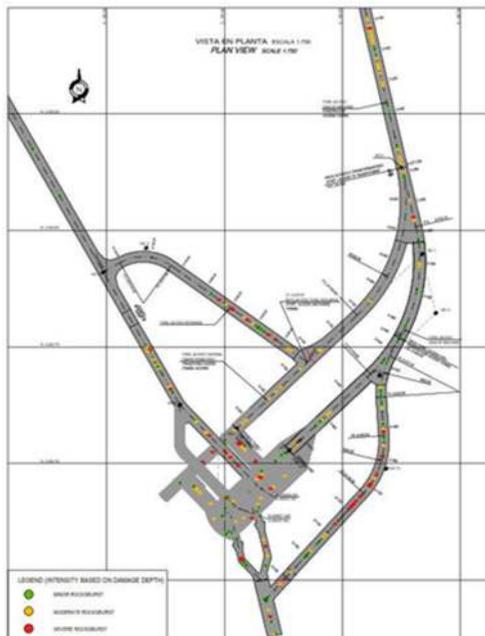
The application of the technical solution for severe rockburst was extended to all the tunnels and caverns exposed to such a critical hazard, with some optimization depending on local geomechanical conditions, as for the dominance of tuff in place of andesitic lavas. Here, probably in relation to both lower UCS and higher CI, frequency and severity of rockburst generally show some reduction. Violent brittle failures persisted in all excavation in andesitic lithologies, as for example illustrated in Figure 13 for the zone around the powerhouse. In Figure 14, the time of occurrence of rockburst after blasting is related to the relative distance from the tunnel face. Most rockbursts occurred within 24 hours and at less than 5H distance (i.e. ~37 m) from the face (H=Height of excavation section). Only three events occurred at 40÷80 m from the face.

Figure 13. Rockburst locations and damage severity in the zone of the Powerhouse

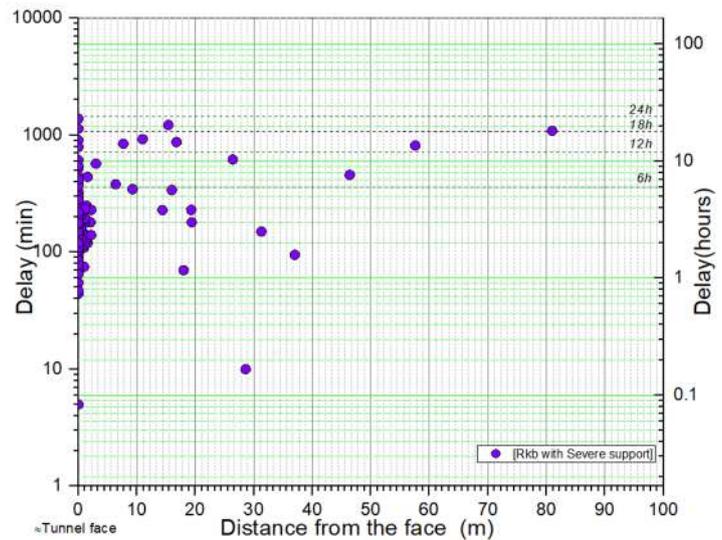
Figure 14: Time of occurrence (Delay) of rockburst after blasting vs relative Distance from the face

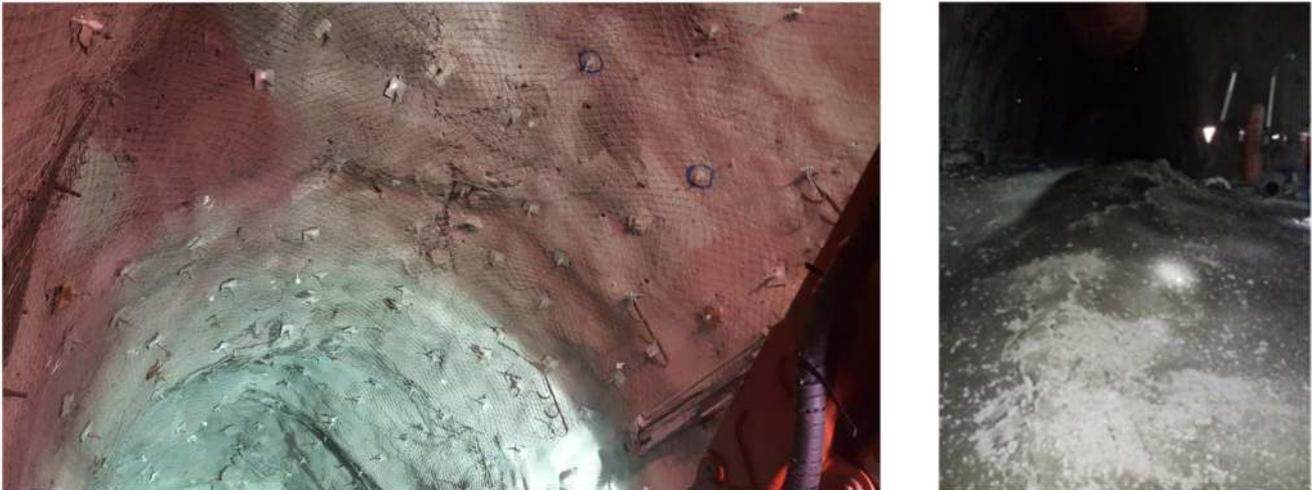
In occasion of the most severe events, the following type of damages have been observed (Figure 15):

Figure 15. Examples of damage of the support systems in crown and invert for severe rockburst events

Due to the support damage, part of the support system capacity has been consumed and it is necessary to estimate the remnant capacity of the support system. Consequently, after a cautious removal of the failed elements, the support capacity can be restored by stepwise integrative measures (see Kaiser, 2013 and Cai and Kaiser, 2018). As anticipated, a key element of the upgraded design agreed with Owner and Contractor was the implementation of a seismic monitoring system. An extremely high seismicity has been observed as resulting from the D&B (Drill and Blast) tunnel advancements: in several occasions more than 10,000 seismic events per week were registered, with some hundred events with moment magnitude  $M_w > -1$  and maximum values up to  $M_w = 1.4$  (see details in Russo G., 2019).
